NUREG/CR-6043 PNL-8614 Vol. 1

Aging Assessment of Essential HVAC Chillers Used in Nuclear Power Plants

Phase I

Pacific Northwest Laboratory

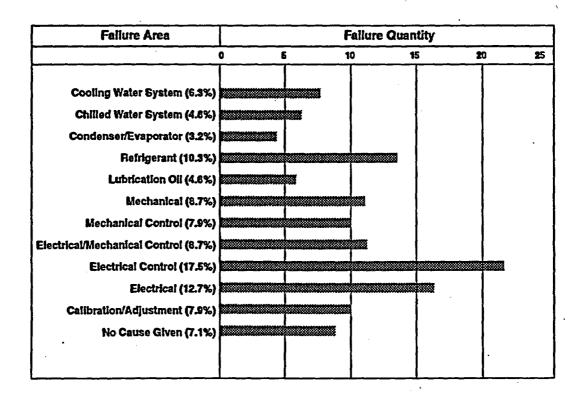
Figure 7.1 Summary of Chiller Failures (LER and NPE Databases)

The information shown in Figure 7.1 summarizes the quantities and failure areas from the LER and NPE

databases. Duplicate failures were removed for this summary. Only failures that caused the chiller to shut down were included. About 11% of the failures were partially caused by flow rate variations in the cooling and chilled water systems and partially by the chiller condition (e.g., chiller fouling, load and capacity limitations, entrance strainers, etc.). Condenser/evaporator failures were only about 3% because most of the age degradation occurs gradually, maintenance access is usually easier, and it is handled during scheduled downtime. The refrigerant/lubrication oil system-related failures accounted for about 15% of the failures. About 17% of the failures were mechanical and mechanical control related. Electrical/mechanical control components caused about 9% of the failures. Electrical and electrical control components made up about 30% of the failures. Misadjustment and miscalibration resulted in approximately 8% of the failures, and the 7% balance

of failures was unknown. Nearly half of the failures were related to control components.
